Motcombe Dovecote 2013

Ruins, Rats and Regeneration by Jo Seaman

Motcombe Dovecote – Ruins, Rats and Regeneration

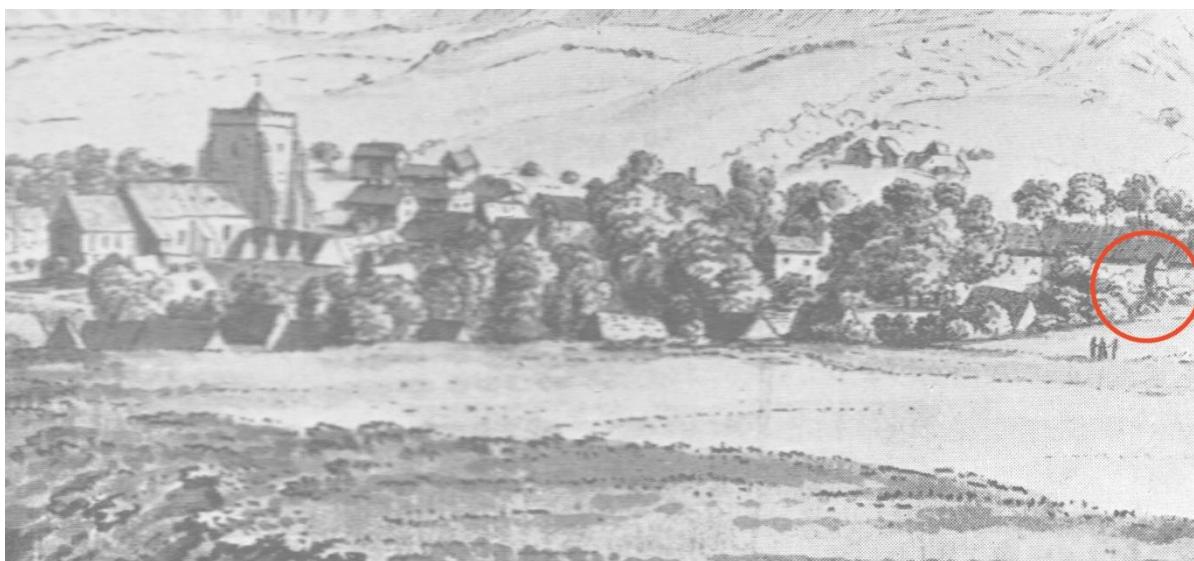
Plate I: Detail from *Eastbourne from the Rectory Mill*, 1785, from a drawing by Grimm. The Dovecote is circled, bottom right (British Museum)

In a drawing by Grimm of 1785 (part of which reproduced here in Plate I) the Motcombe barns and Dovecote can be seen on the extreme right. If this is an accurate representation, and it seems to be, the Dovecote appears to be of a very similar form to the present building. It also does not seem to show the terrace that now surrounds at least half of the building. This would indicate that it developed after alterations to the farmyard in the Nineteenth Century. However, there is a definite rise to the ground behind the building so this evidence is not conclusive. Archaeological testing would certainly clear this issue up fairly easily.

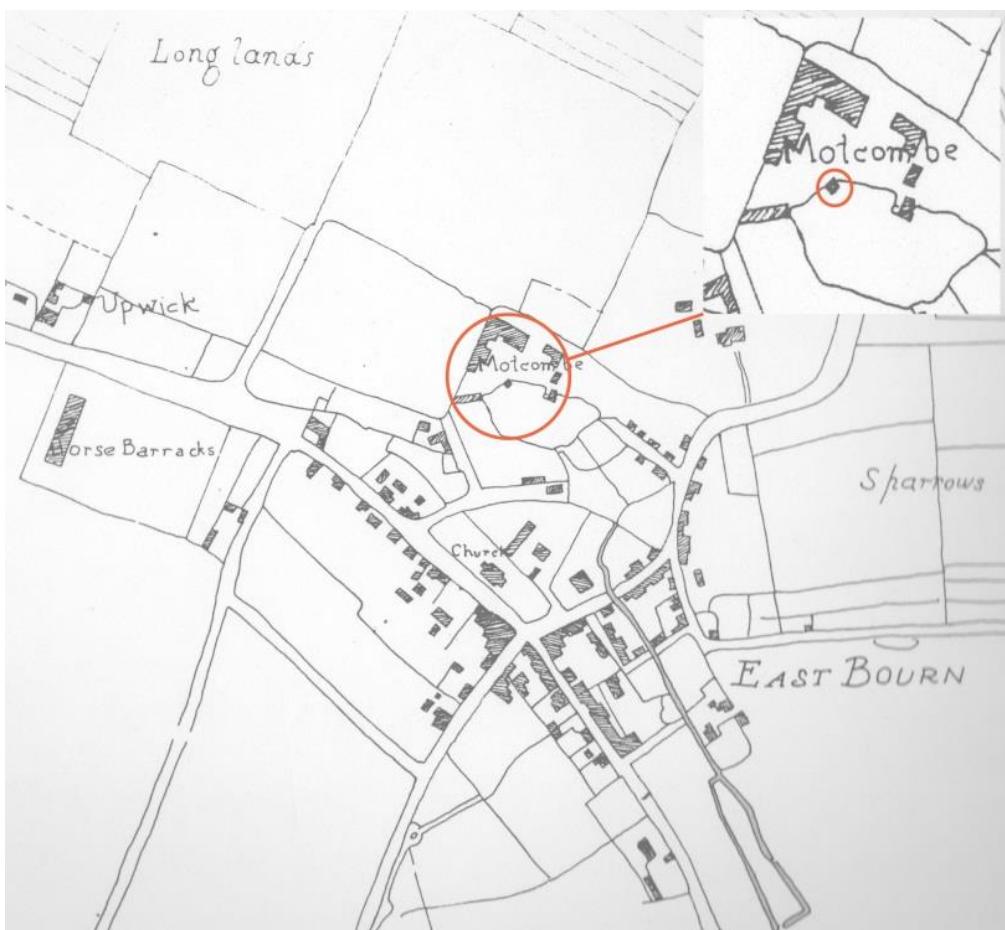
Figure 3: A Copy of the Figg Map of 1817, with Motcombe Farm Circled and detail of the Yard (inset)

The 1817 Figg map (see Figure 3 below) shows the farm buildings and, presumably the Dovecote, though it is erroneously recorded as a square building before it disappears from the Tithe Map of the early 1840's, only to be recorded again, as a circular structure in the 1870 Ordnance Survey map where it remains until the most recent map of 1910 (see Figures 6 & 7).

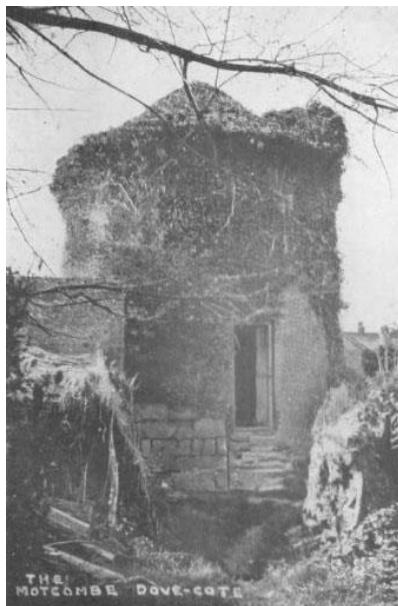
Plate 3: Photograph of the Dovecote, published 1912 (Budgen)

Plate 4 shows the building as painted by a local student F. Andrews in 1909 (it is almost exactly the same view as appears in Budgen 1912, also reproduced here as Plate 3.), before renovations that would strip it of the original Dormer or entrance for the pigeons. When comparing this view (and the Budgen photograph) with an undated view of around 30 years later, we can see some changes to the building. Firstly all invasive ivy has been removed and the roof has been ‘renovated’ (a date of 1931 is suggested for these works from graffiti on one of the main cross beams, but no record could be found in the Council Minutes and the large buttress to the left of the door has been increased in height (almost doubled) and repointed. The stone steps also seem to have been replaced with concrete at this time and repairs were carried out. The lower, brick buttress (the primary target of this excavation) to the right of the door as we look at it is shown exposed in the painting from the early Twentieth Century (see Plate 4) but in recent years has been all but buried.

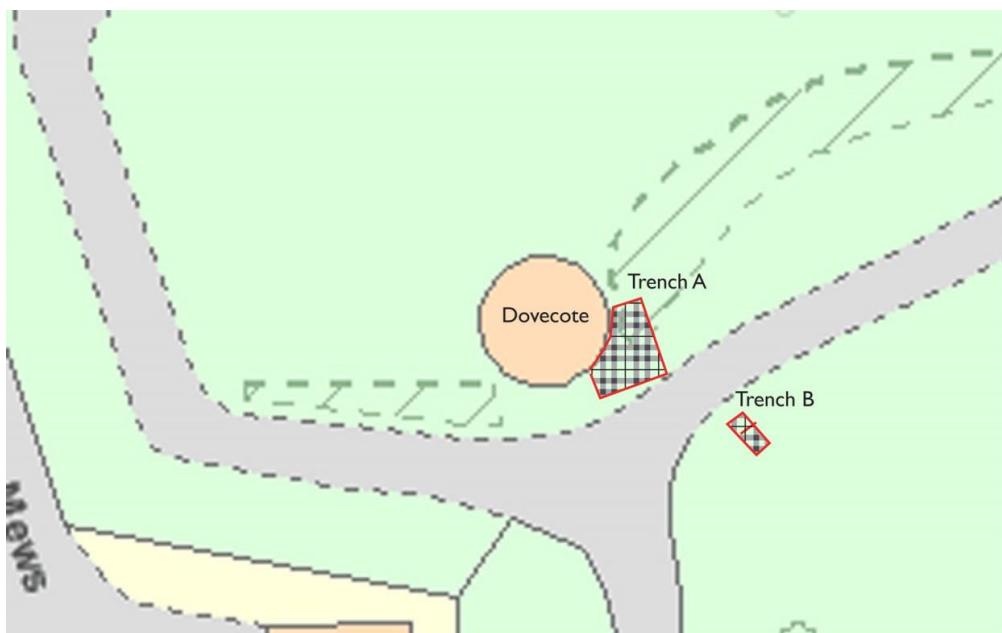
Figure 5: Motcombe Gardens Dovecote – Trench Locations

Trench A was placed to the east of the existing doorway and was 3m by 3.5m by 1.4m. The aim of this trench was to try to recover dating material from the buildings' foundations and to investigate a brick buttress.

Trench B was placed across the path to the south east of the Dovecote and was 2.4m by 1m. The aim of this trench was to establish whether the pond had once formally extended to this point and to see if any other farm yard features would be present opposite the entrance to the Dovecote.

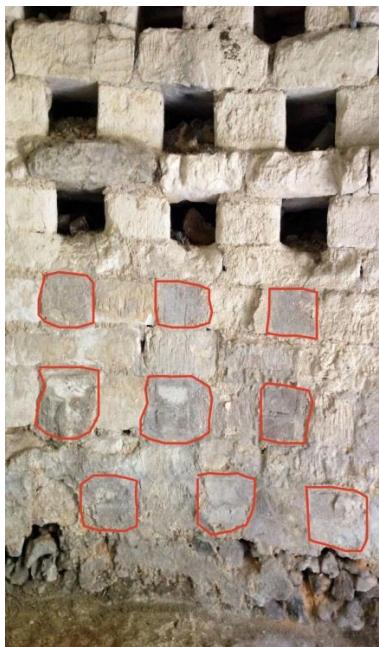
One of the first things that strikes the visitor to the interior of the Dovecote is the sheer quantity of nest boxes that remain within its walls. The second is that they seem to stop roughly 0.9m from the floor of the building. Closer inspection of this 'box-free' area shows that the nesting holes actually once went all the way down to the exposed flint wall (roughly 0.3m from the floor) giving a further three rows, or roughly 100 more boxes. They have each been carefully filled by two inserted bricks (that would appear to be of Eighteenth or early Nineteenth Century), end on, that have been mortared in place. We should also note that the original bottom line of nesting boxes does not line up with those above it, a feature that is seen elsewhere in the building and noted earlier.

Plate 5: The lower tiers of nesting boxes with blocked in holes outlined red

The roosting ledge that once ran above the lower two rows has also been removed by roughly chopping it off flush to the wall. All of this has then been carefully plastered over with a lime mortar and been given a smooth finish. The question must now be answered as to why this was carried out, and the answer is rats or more specifically to protect the young birds from the attention of ravenous brown rats (*rattus norvegicus*). When Dovecotes were first introduced the main predators of the young squabs were birds of prey and members of the stoat or polecat family. These were combated by external measures such as having small openings or *louvres* high on the walls or roofs of the buildings and by their placement away from trees that could offer predators cover.

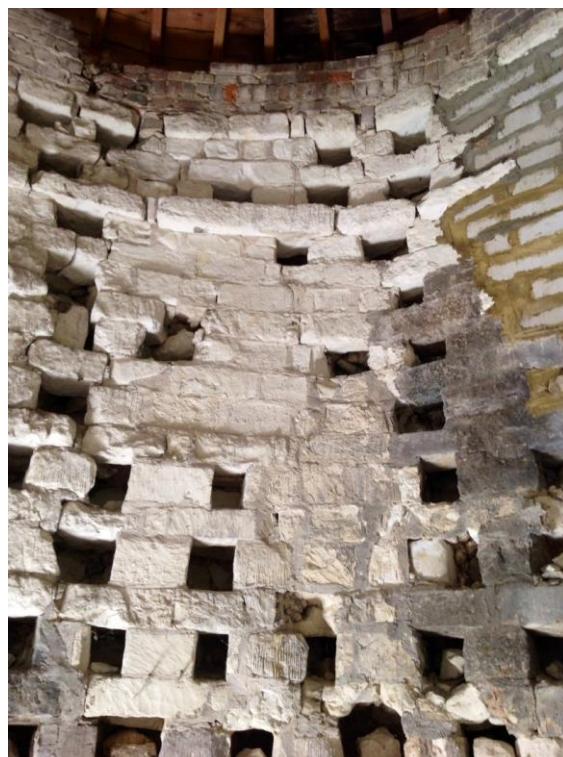
This is just conjecture but there is tantalising evidence left that could just verify this theory and the chalk block repairs give us this.

Plate 6: Chalk blocking repairs, weathering on 'original' chalk fabric and unsympathetic mid Twentieth Century breeze block repairs

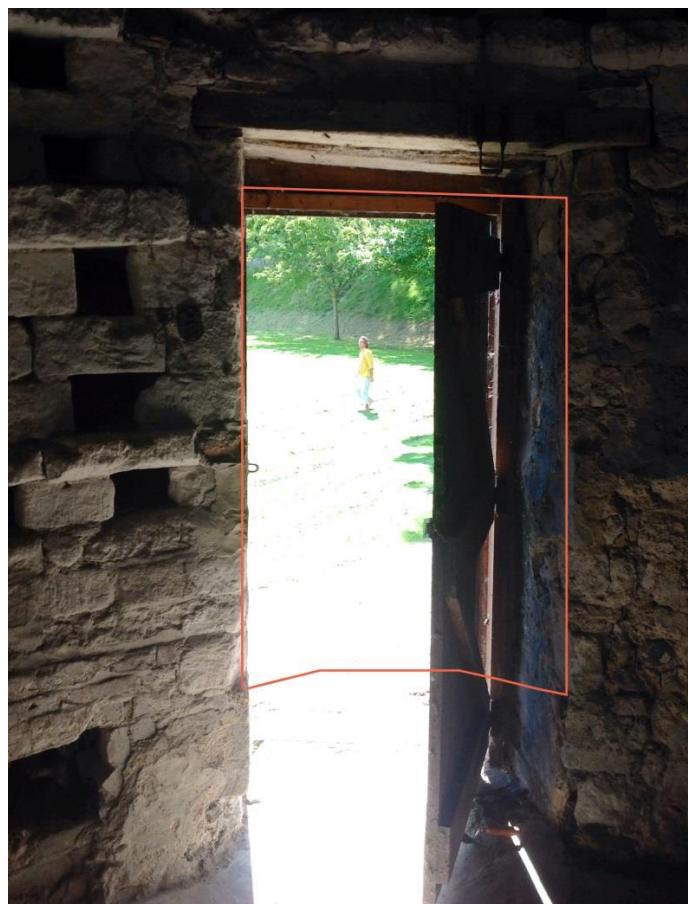
Plate 7: The door of the Dovecote with the original size marked in red. The wear to the chalk jamb can be seen to the bottom left, ‘original’ masonry of the step just below it and damage caused by replacing the door lintels top centre.

The present door lintel looks to have been replaced on a number of occasions and the chalk masonry on either side has been blocked and repaired. This would indicate that although the height of the door (as opposed to the bottom length) has not been altered the construction of it has been. More recent brickwork has been used to front the doorway, presumably as a result of the alterations, but like the rest of the building, this appears to be phased and some early post medieval tile and brickwork seems to be surmounted by much later Nineteenth Century ceramic building material.

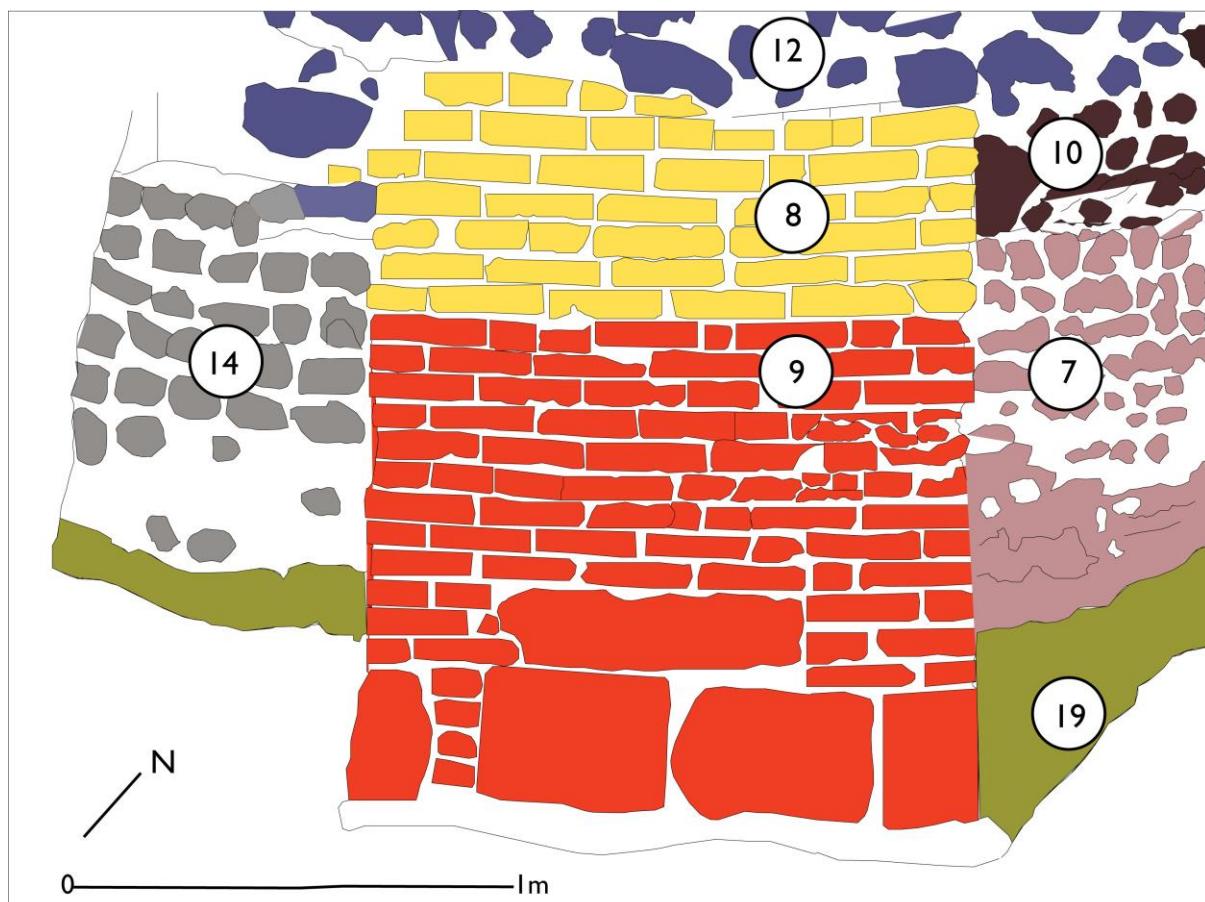
Figure 10: Drawing of the Brick Buttress, Trench A

Butting onto this is a hard mid-red brown fired brick feature (**008**), which combined with (**009**), makes up the buttress using a rough stretcher bond on the South-Eastern wall of the Dovecote. They are both made of a similar brick, which suggests that they are of a contemporary date, no later than Late 18th Century. However, the lime mortar which holds the bricks in (**008**) is a lot more degraded. A cause of this could be (**008**)’s higher exposure to the elements, and its undergoing of various phases of weathering. In the painting of 1909 this brick buttress is shown exposed for the top courses lending credence to this interpretation.

(**009**) which sits underneath (**008**) is the bottom half of the buttress which is positioned on the South-Eastern wall of the Dovecote. It too, has been constructed of a hard mid-red brown fired brick but features some notable differences. The first is that it is actually cut into the ‘original’ foundations of the building, and the other is in the supports appearance. On the bottom row is three large pieces of reused dressed greenstone, which provide real strength in the lowest course. Next to them are two yellow bricks which indicate a late Eighteenth Century date at earliest for (**009**)’s construction, even though some of the material used appeared to be older and hence reused.

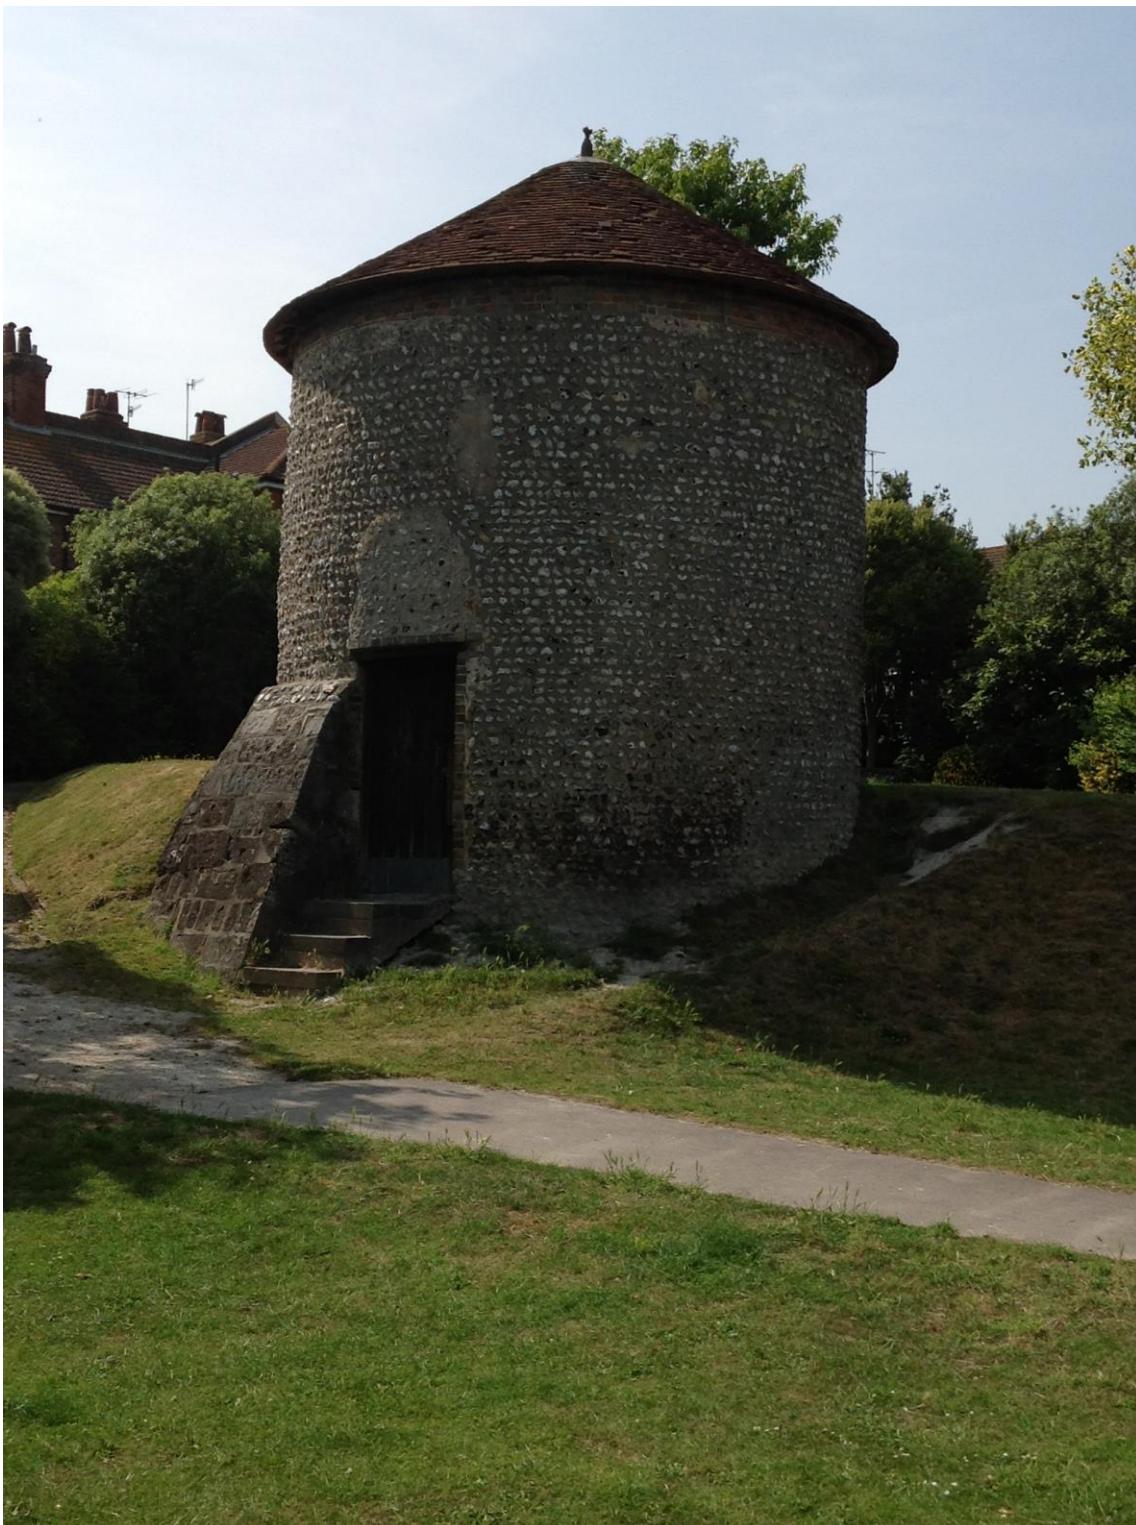
Plate 8: Motcombe Dovecote today from the south east

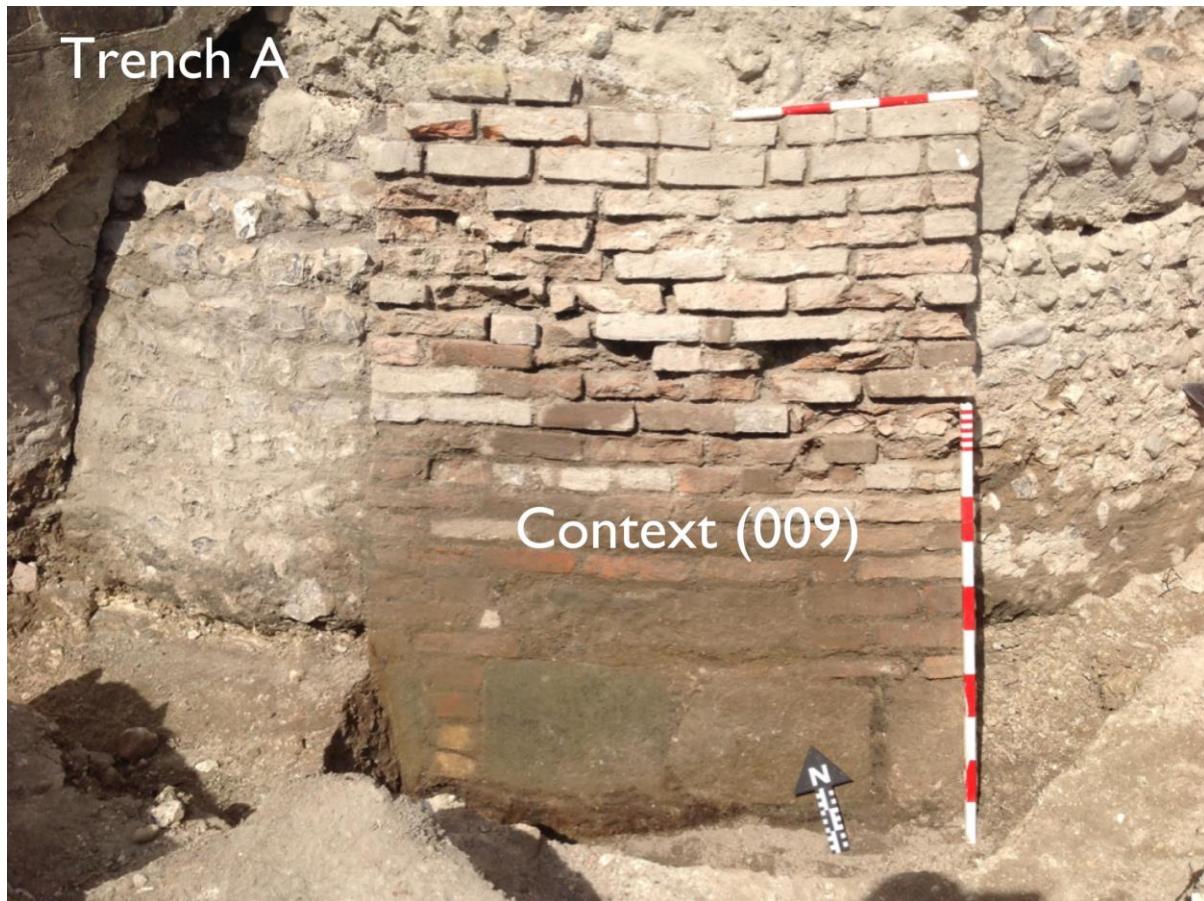
Plate 10: Trench A Context 9, the brick buttress

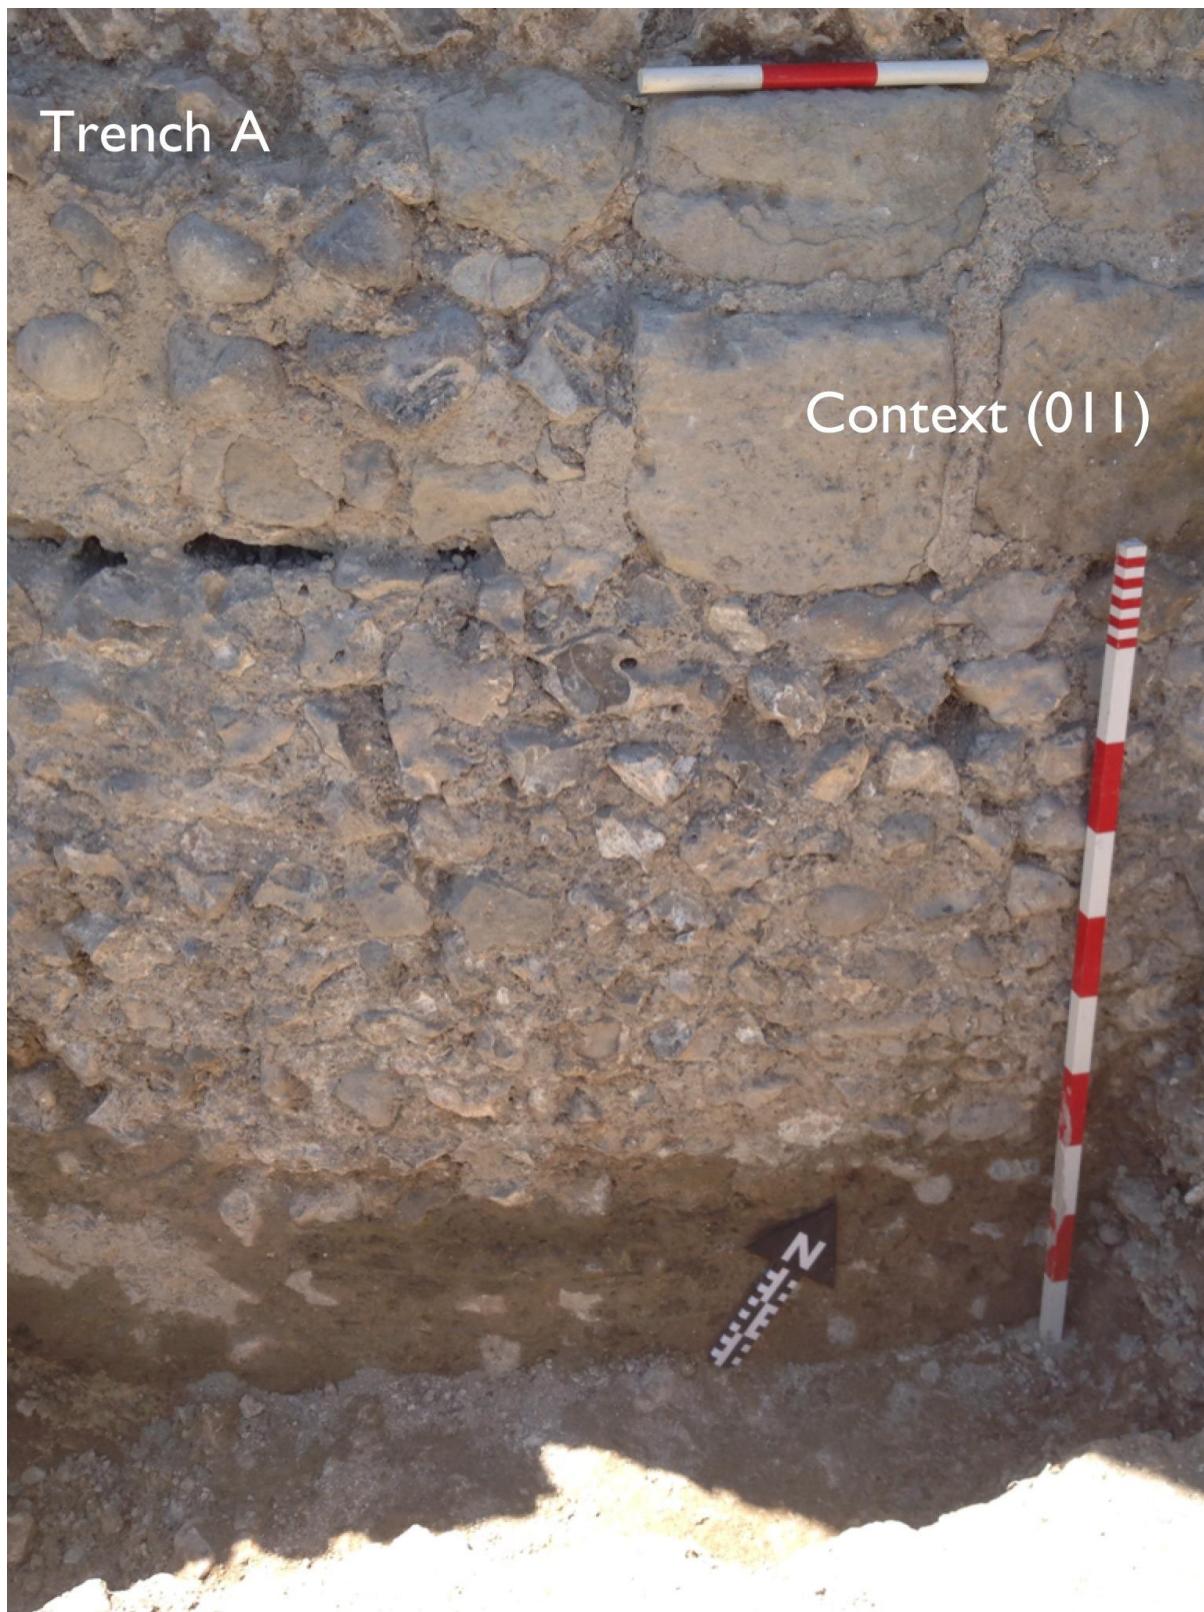
To the right of this was a sub-rectangular structure (**011**) made of two exposed dressed local greensand blocks. The blocks have been repointed but may still represent the original Medieval/Post Medieval foundations or more likely, a decorative course.

Plate 11 – Trench A Context 11, the dressed sandstone blocks

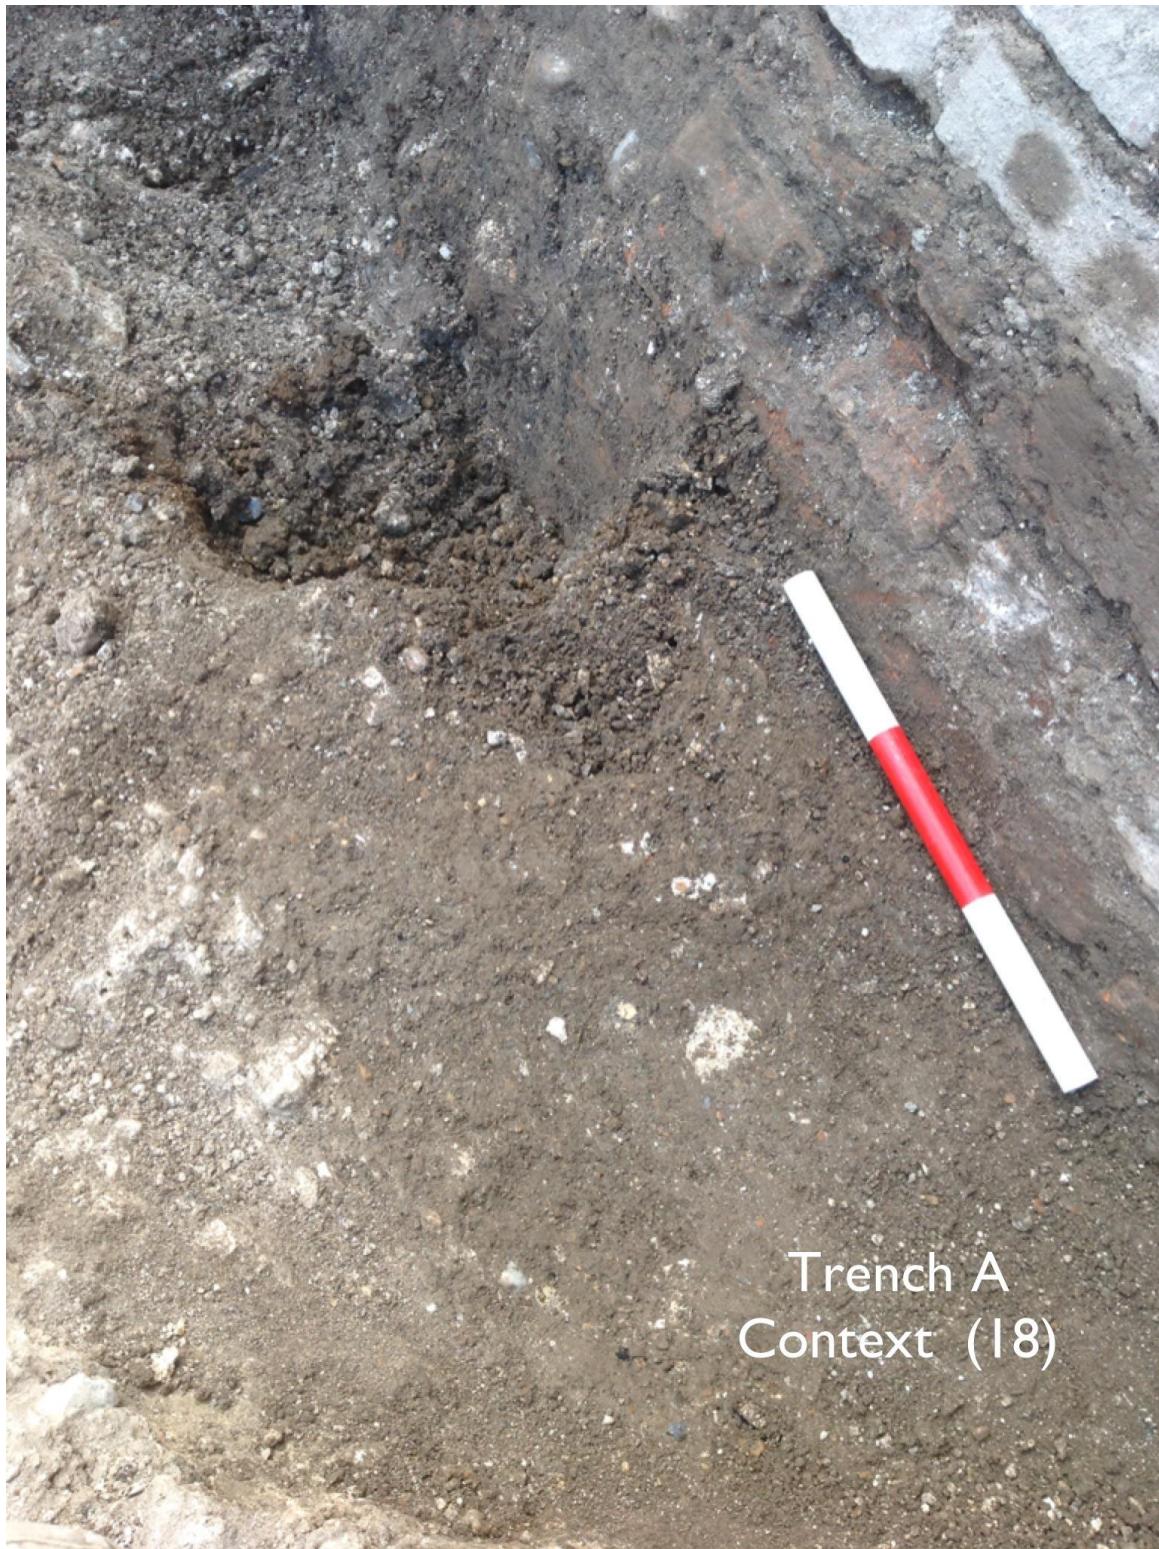
Plate 12: Trench A Context 18

010	A hard sub-rectangular poorly constructed fill or repair of the ‘original’ foundations of the Dovecote. The fill is mostly irregular flint and greensand blocks
011	A hard grey/green sub-rectangular structure made of dressed local greensand. Appears to have been repointed and may represent the original medieval/post medieval foundations or coursing
012	A hard grey to brown structure made up of a combination of knapped and cobbled flints. Context 12 represents the main exterior body of the Dovecote including all later repairs
013	A fairly firm (with loose patches) dark soil/clay mix which runs alongside the Dovecote wall
014	A flint wall which butts onto the Western edge of (009)
015	The foundation for the stairs which lies in front of (014) and above (013)
016	The concrete stairs which lie above (015)
017	Cut of wall trench
018	A degraded silt/clay relatively compact, mid brown-grey fill of cut.

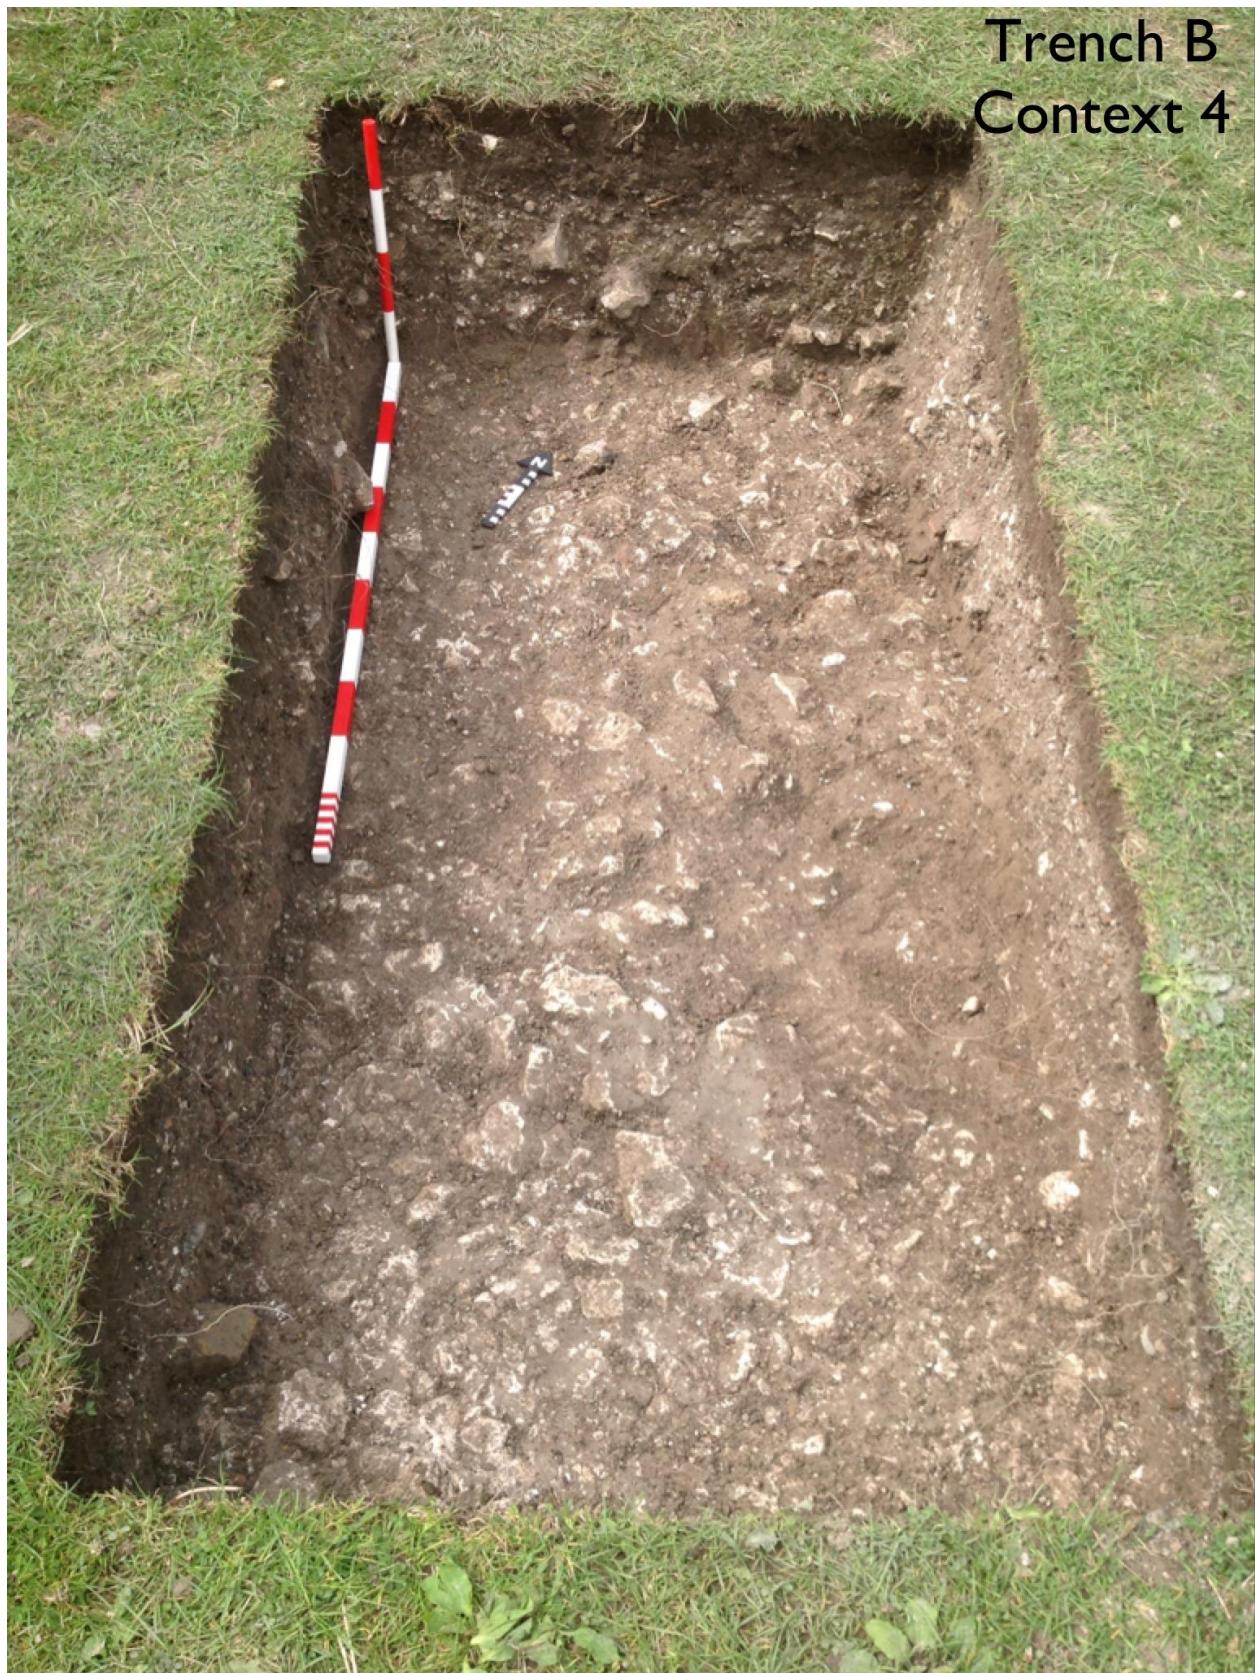
Plate 13 – Trench B Context 4

Context	Description
001	Dark to mid brown thin topsoil layer
002	Light grey/brown chalky loam with clay
003	Pale cream to white tip of material used to fill a gap between the building and bank
004	Cut of trial trench opened and abandoned in March 2013
005	A friable mix of mid brown clay, grey loam and chalk fragments, creating a linear fill following the line of the Dovecote wall
006	Flint foundations for steps
007	Flint walling mortared with a high proportion of charcoal
008	A hard mid red/brown fired brick addition forming the top seven courses of brick work on the ‘buttress’ in a stretcher bond. Lime mortar is notably degraded.
009	A hard mid red/brown brick support (in a partial stretcher bond) cut into the ‘original’ foundations of the Dovecote. Three dressed greensand blocks are also present at the bottom of the course to add extra support

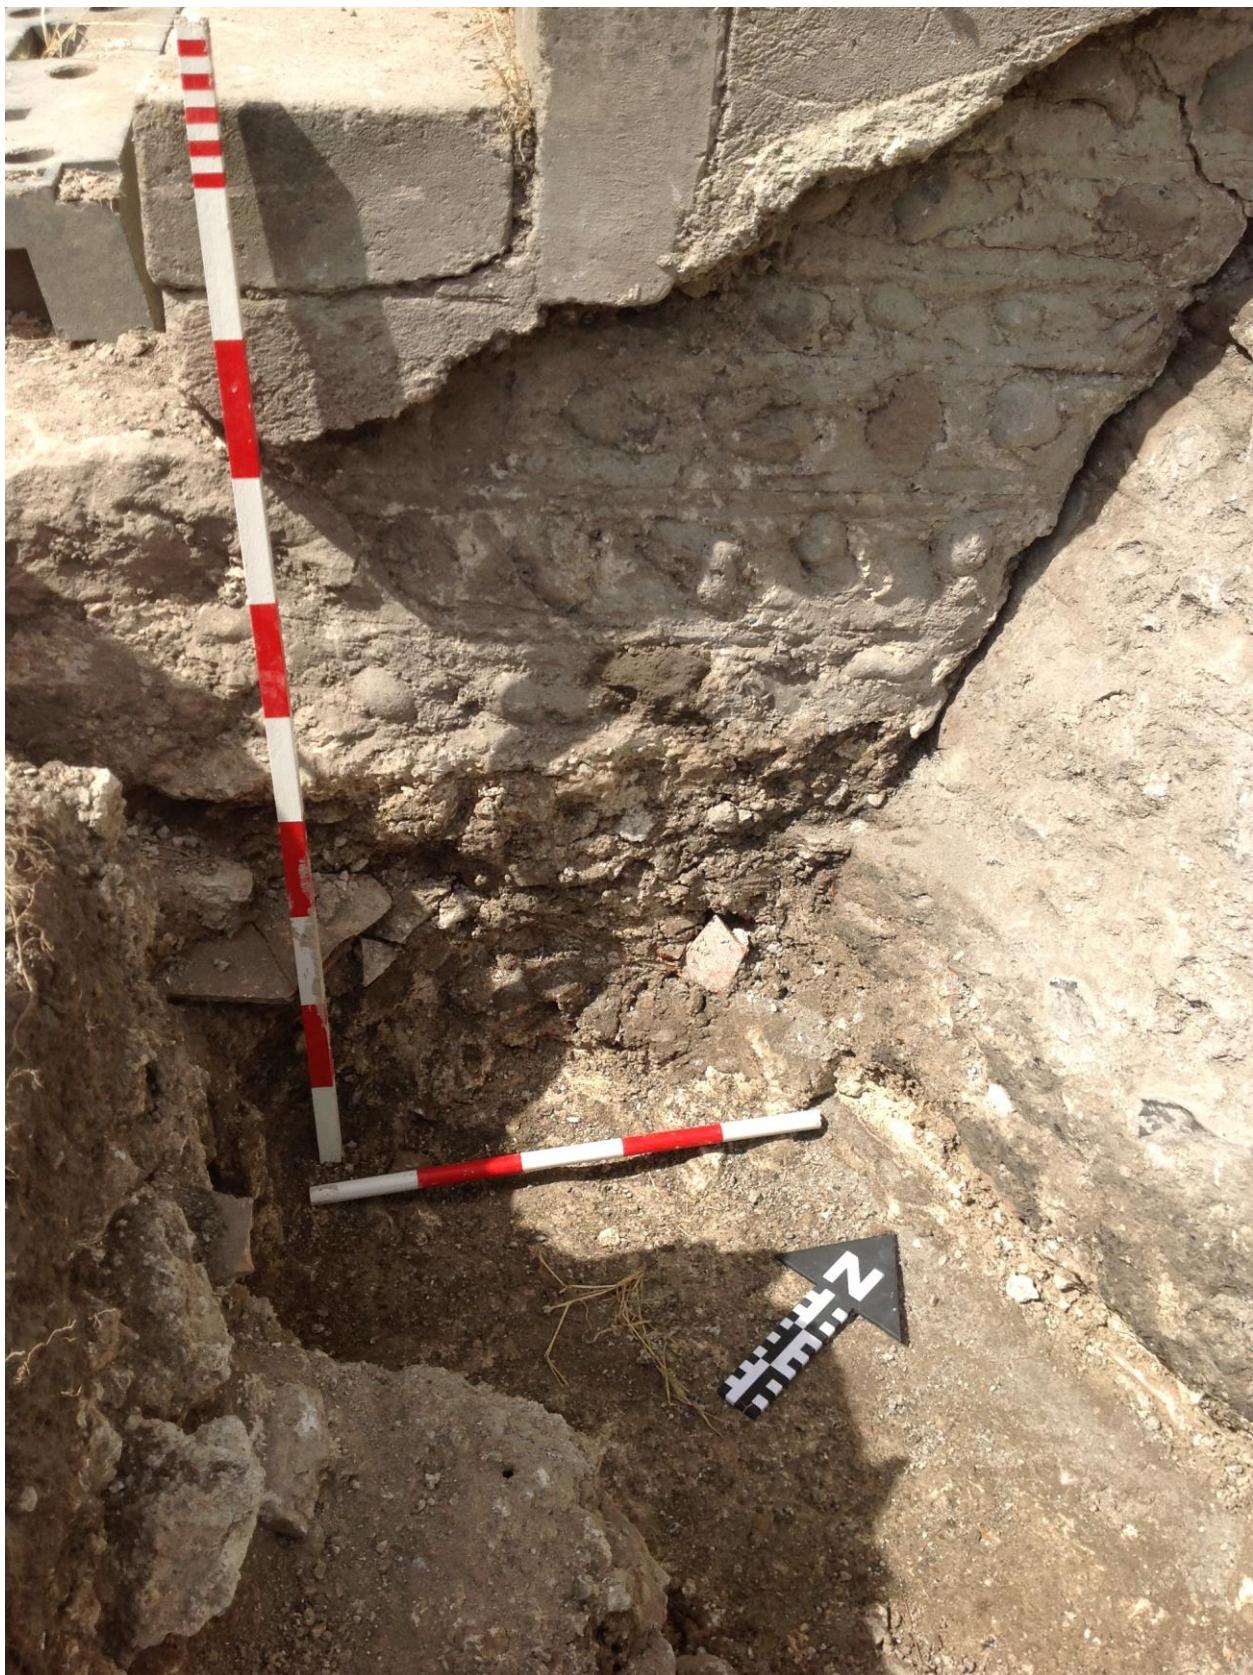
Butting onto the most Western edge of (009) is a 19th-Early 20th Century flint reinforcement (**014**) constructed to strengthen the front of the building. It continues behind the foundation for the stairs of the Dovecote (**015**).

The foundation for the stairs (**015**) put in at some point during the mid 20th Century lies in front of (014) and above (013).

Plate 15 : Trench A, phases of repair and reconstruction around the stairs

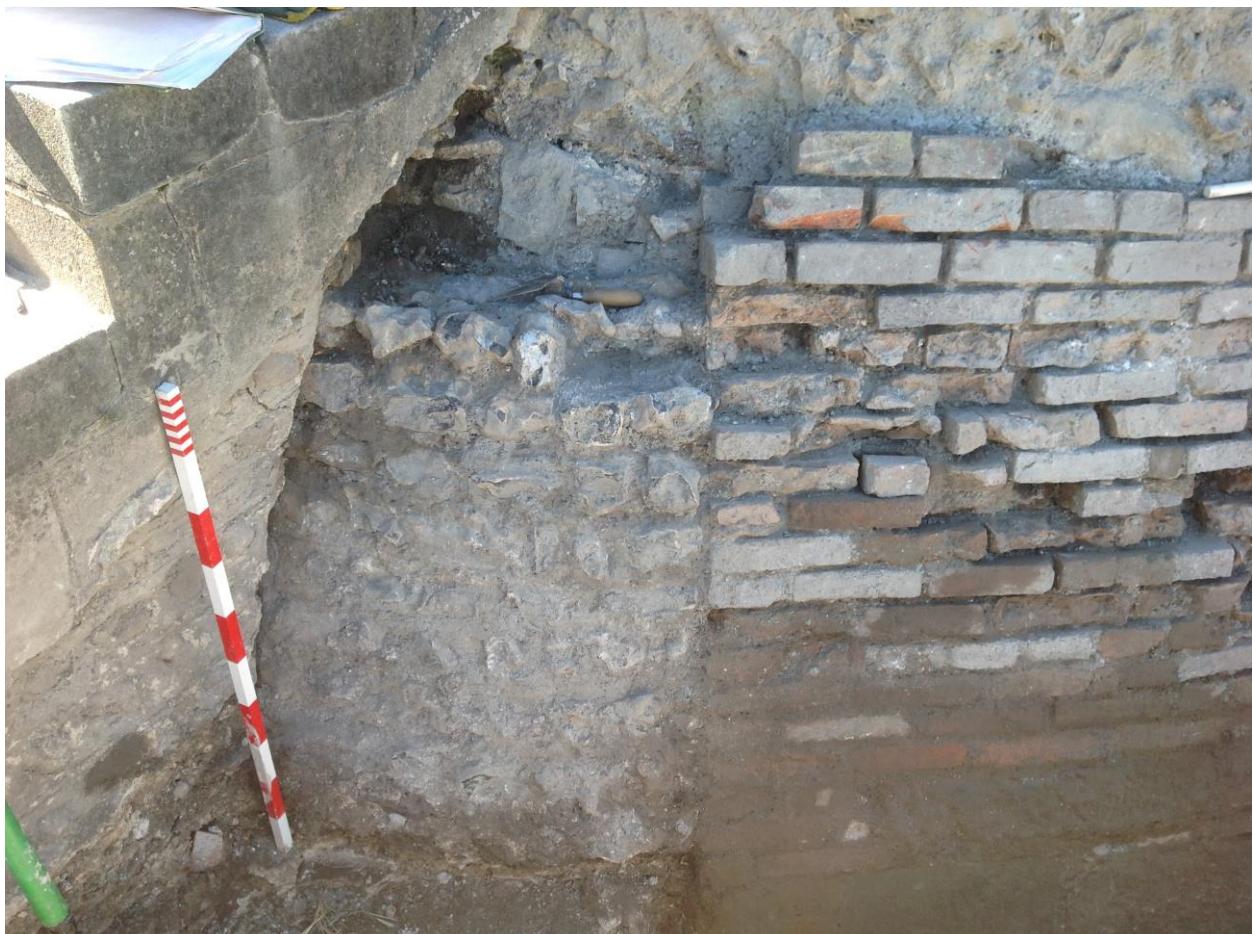
Plate 16 : Phases of repair around the stairs and to the west of the brick buttress

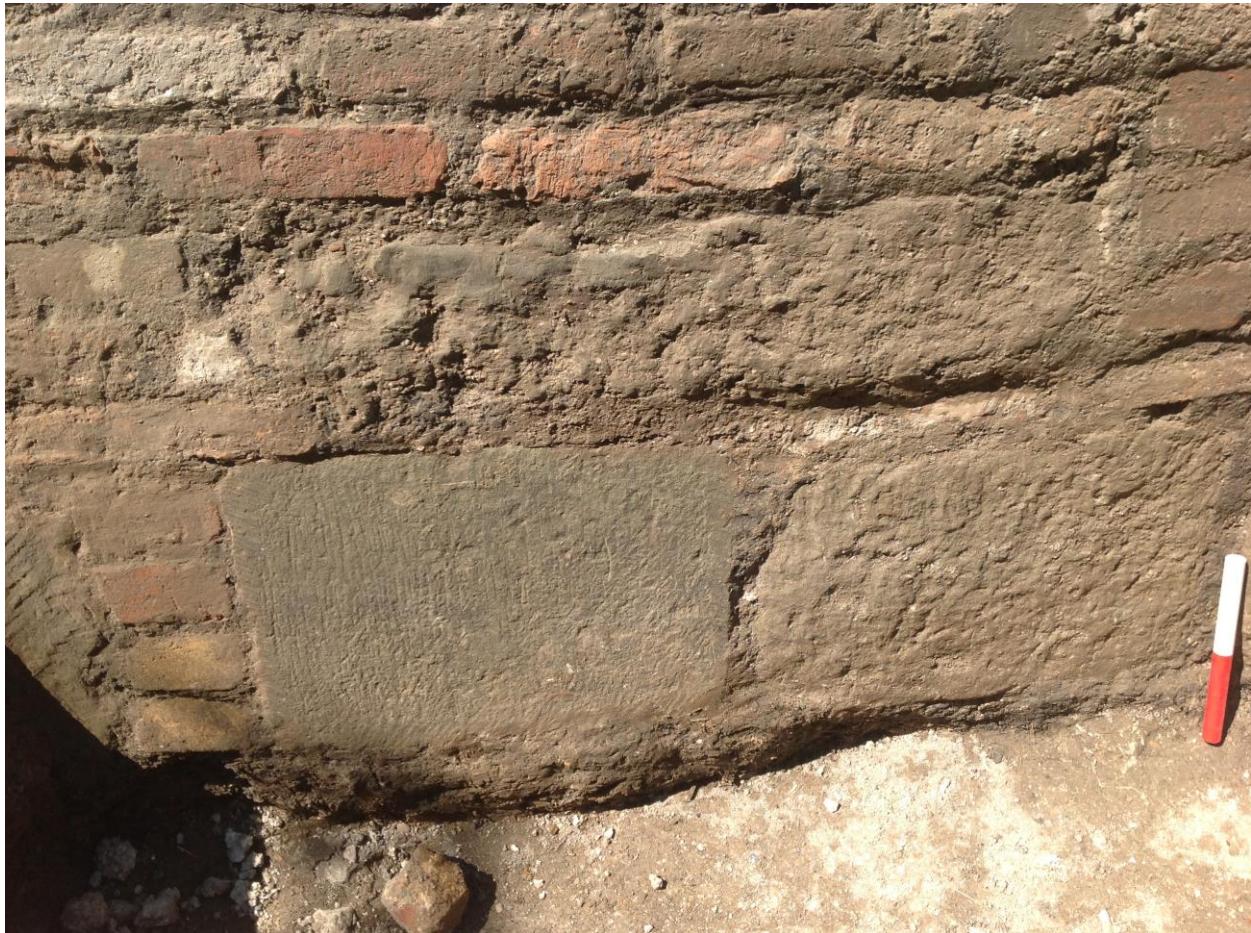
Plate 17: Trench A the base of the buttress showing re-used greensand blocks and yellow brick fill (bottom left)

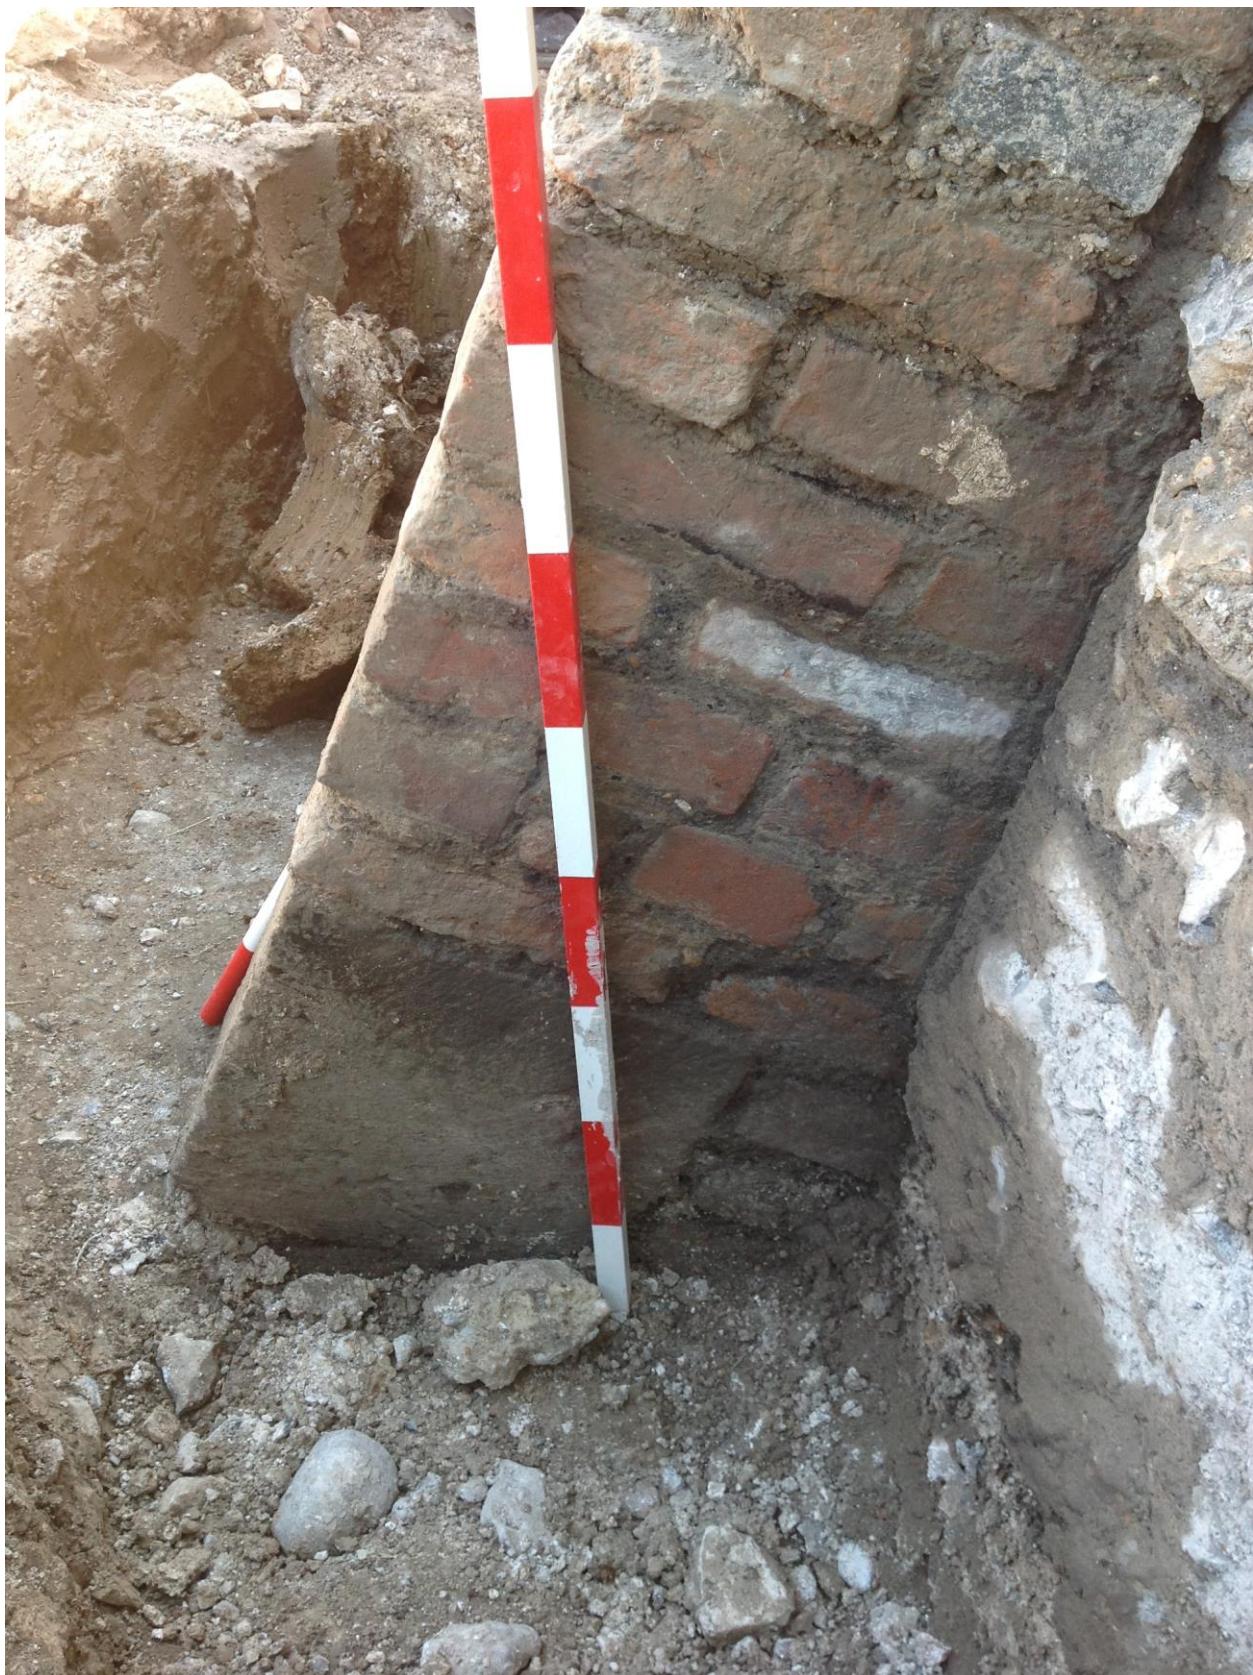
The phasing of repairs has largely been set out above, with the earlier building seemingly at least partly underpinned and later buttressed to repair and strengthen areas of weakness. The brick buttress would appear to be of one phase and judging by the brick used (particularly the two yellow bricks at the base of the buttress) cannot be much earlier than the late Eighteenth Century, though earlier re-used materials also appear within its structure.

Plate 18 : The brick buttress showing how it has been cut into the body of the Dovecote
