Motcombe Dovecote 2013

Ruins, Rats and Regeneration by Jo Seaman

Motcombe Dovecote – Ruins, Rats and Regeneration

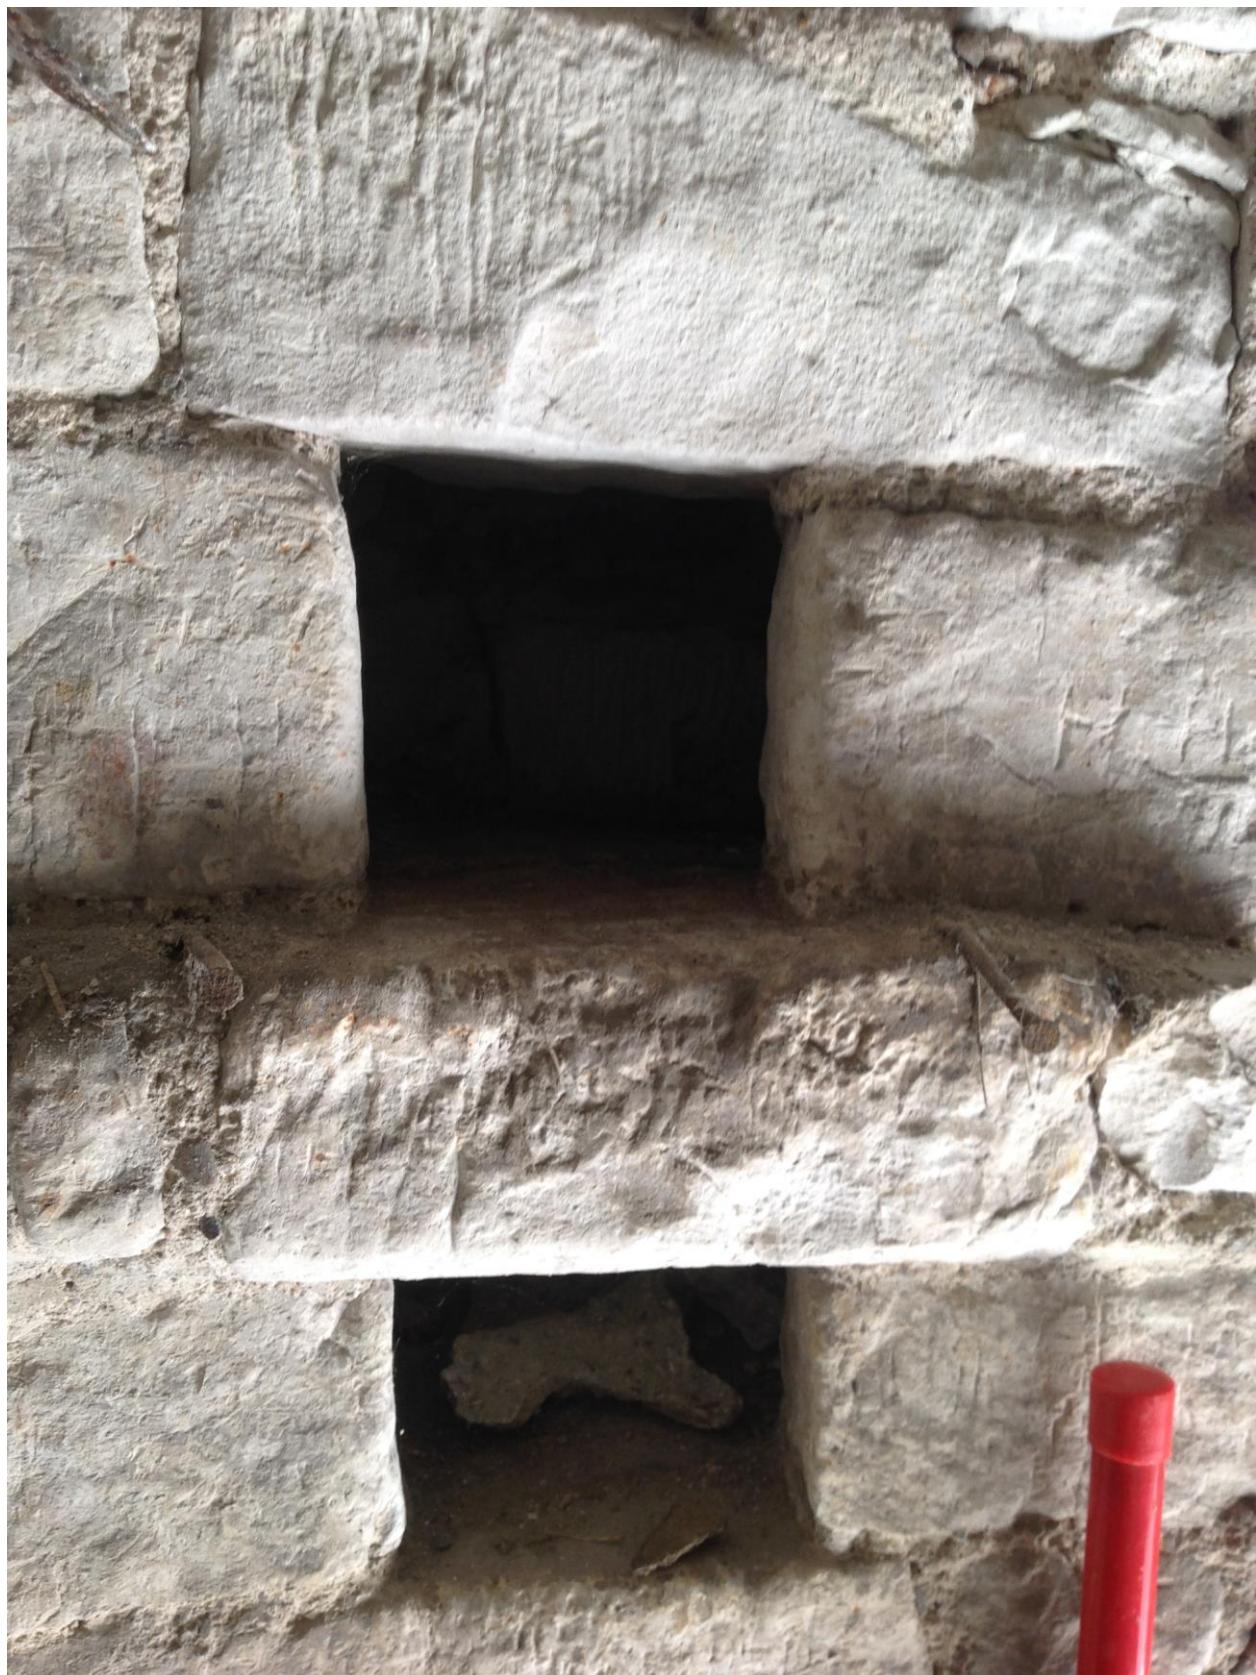
Plate 19 : Interior of the Dovecote, two of the nesting holes

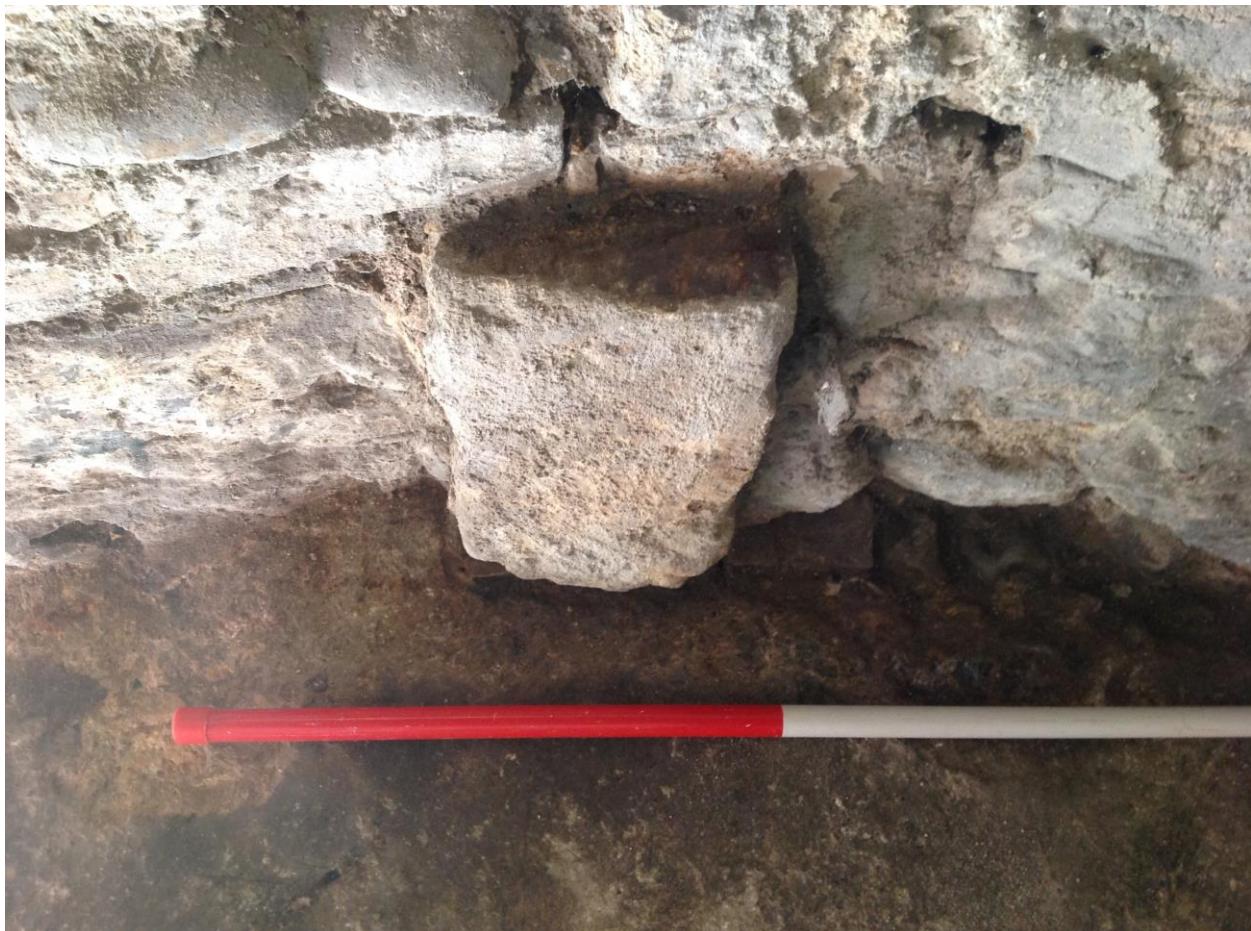
Plate 20 : Interior of the Dovecote, possible floor or platform support
